POLISHING TREATMENT

CONCRETE FLOORS
GRINDING AND POLISHING
TREATMENT

Prima
PAVIMENTI SPECIALI

GRINDING AND POLISHING SYSTEM

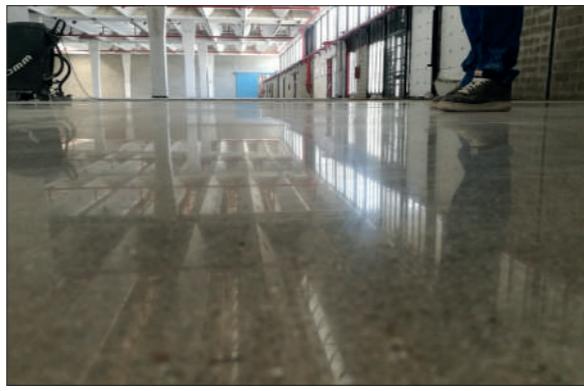
Coloured finishing

Colouring with non-film impregnating agents can also be applied to customise aesthetics without compromising durability.

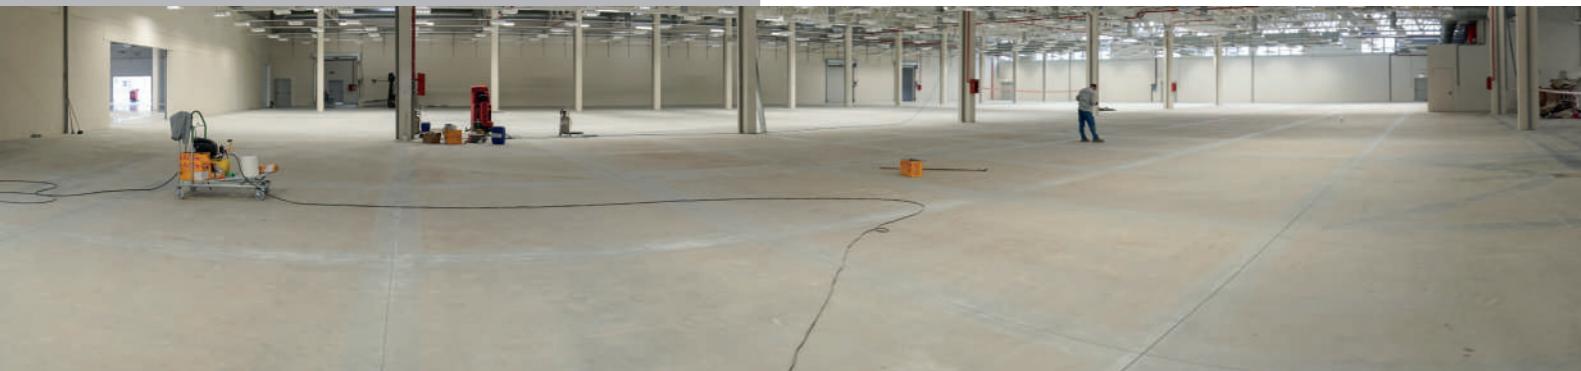
Project
OBI Roma Casilina - Italy

Concrete floor grinding

Concrete grinding is a mechanical process involving the use of specialized machinery with progressively finer-grained diamond abrasives to obtain a smooth, even and uneven surface.

This process gets rid of imperfections, wear marks, scratches and dust caused by carbonation, improving the flatness and safety of the floor, which is important in environments with forklift traffic.

The surface must be prepared for subsequent treatments, and this process is known as grinding. The porosity of the cement is opened by sanding, which allows better adhesion of primers or protective products.

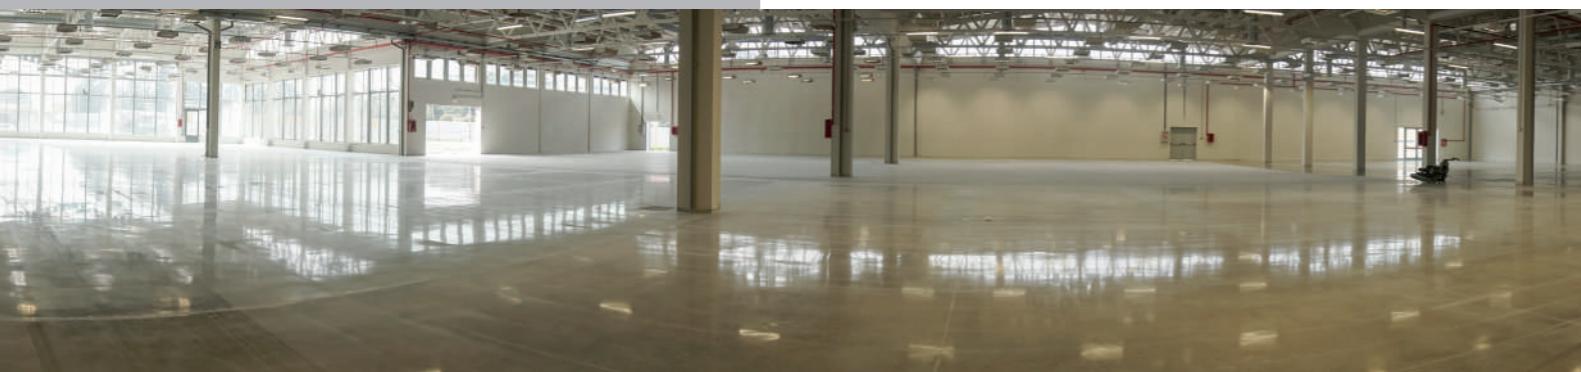
Project
OBI Roma Casilina - Italy

Treatment of contraction joints

Contraction joints are sealed by cleaning them, inserting a polyurethane filling and then sealing them with a fast-elastic polyurethane material.

The next step is to remove any remaining dust, debris, and carry out a thorough clean, before polishing the surface.

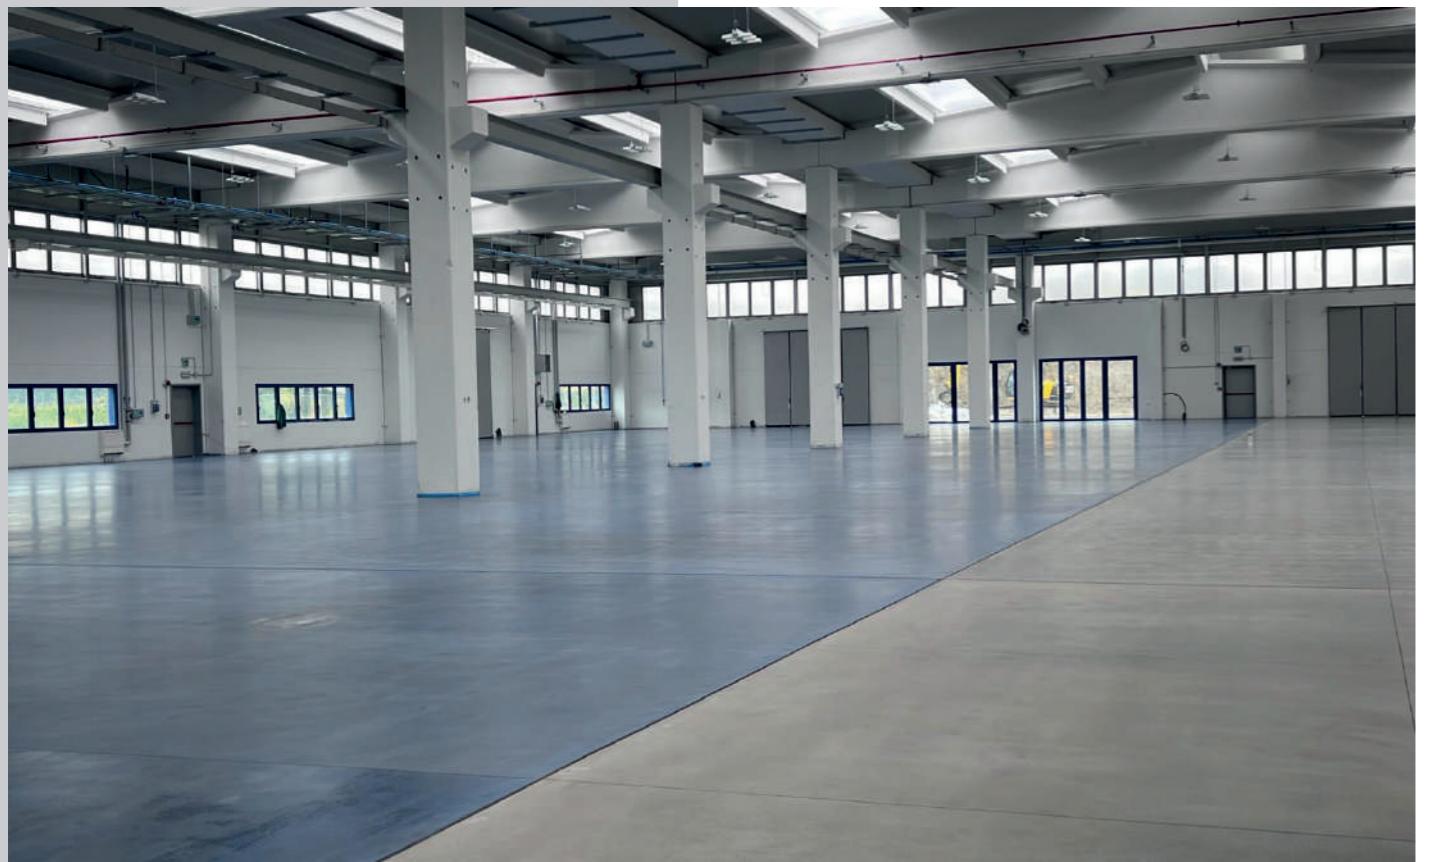
Colour-polishing of a warehouse.
